Product Name	Spanish Style ASA Roof Tile
Brand	ZXC
Place of Origin	Foshan city,Guangdong province,China(Mainland)
Material	Acrylonitrile Styrene acrylate copolymer,Polyvinyl chloride, Calcium powder,other chemical materials
Guarantee	25 years
Certification	ISO9001 / SGS / CE / Test Report
Minimum Order Quantity	100 square meter
Delivery Time	1x20GP for 6 days,1x40GP for 7 days
Supply Ability	We have 8 produce lines,about 13500 square meter every day
Payment Terms	T/T , firstly pay 30% deposit,before loading container pay rest of payment
Shipping	Full Container Load (FCL) Service,We do it by myself. Less than Container Load (LCL) Service,We find our agents to do it.
Package	Pallet or PE bag
Port	Guangzhou / Shenzhen / Foshan
Application	Villa roofing,House roofing,Garden,Grange,Container house, Flat to Slope Project,Etc

Model Number	#1050-160-30
Type	Spanish Style
Overall Width	1050mm
Effective Width	960mm
Thickness	2.3mm / 2.5mm / 2.8mm / 3.0mm
Length	Must be a multiple of section
Color	Orange / Red / Grey / Sky blue / Dark green
Wave Spacing	160mm
Wave Height	30mm
Section Length	219mm

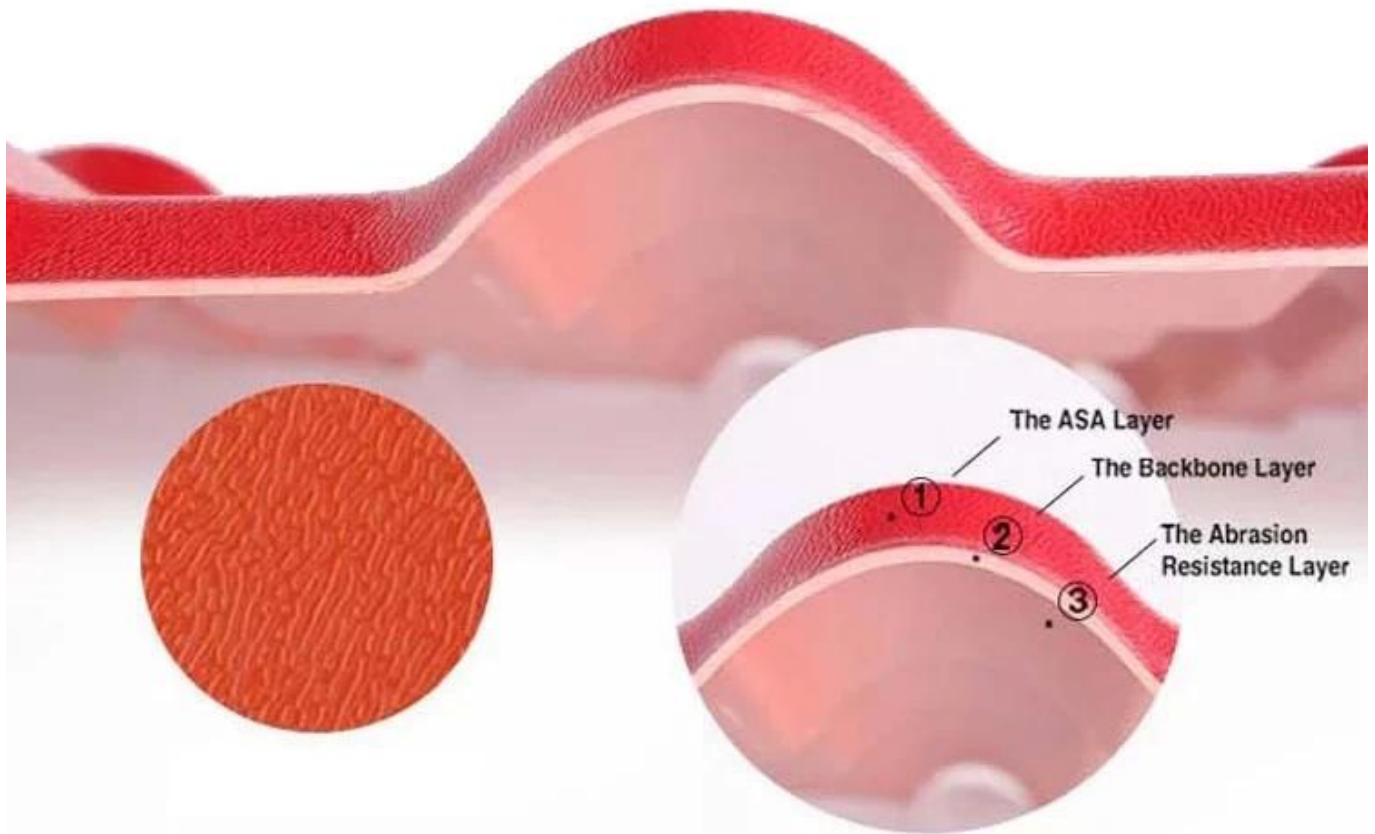
Structure

Surface: Imported ASA raw materials from the world's top 500 GE company, Super weather resistance, truly 10 years don't have color fading. The standard is that the thickness of the surface reaches 0.15mm, We can reach 0.15-0.18mm.

Medium: The material is Polyvinyl chloride and Calcium powder, the proportion is 1:1. This is the best ratio after many trials. This ratio guarantees the strength and toughness of the product.

Bottom: The important material also is Polyvinyl chloride and Calcium powder, but add other chemical materials. We are make the same color as the surface color and white color. Gloss of products is best in the industry.

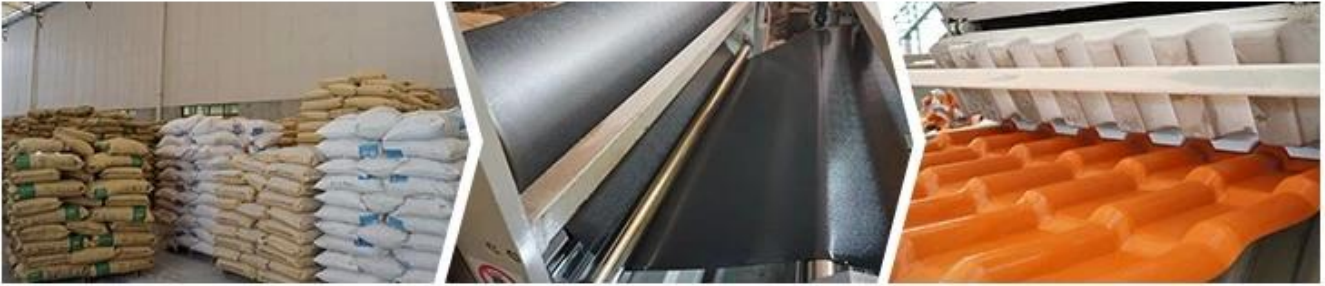
PRODUCTION PROCESS

① Raw Materials

② Extrusion

③ Compression Molding

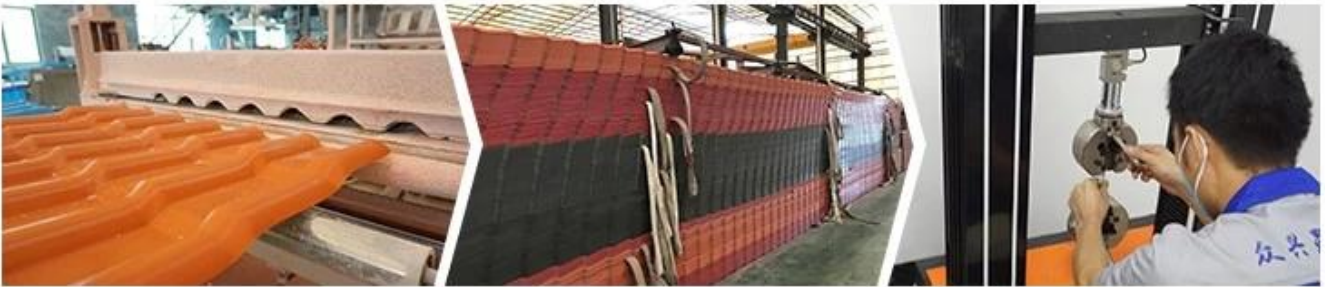
④ Cutting

⑤ Finished Product

⑥ Inspection
